## S6 and S9 AUDIO MODIFICATION

Prepared by: EDC Inc.

January 24, 2008

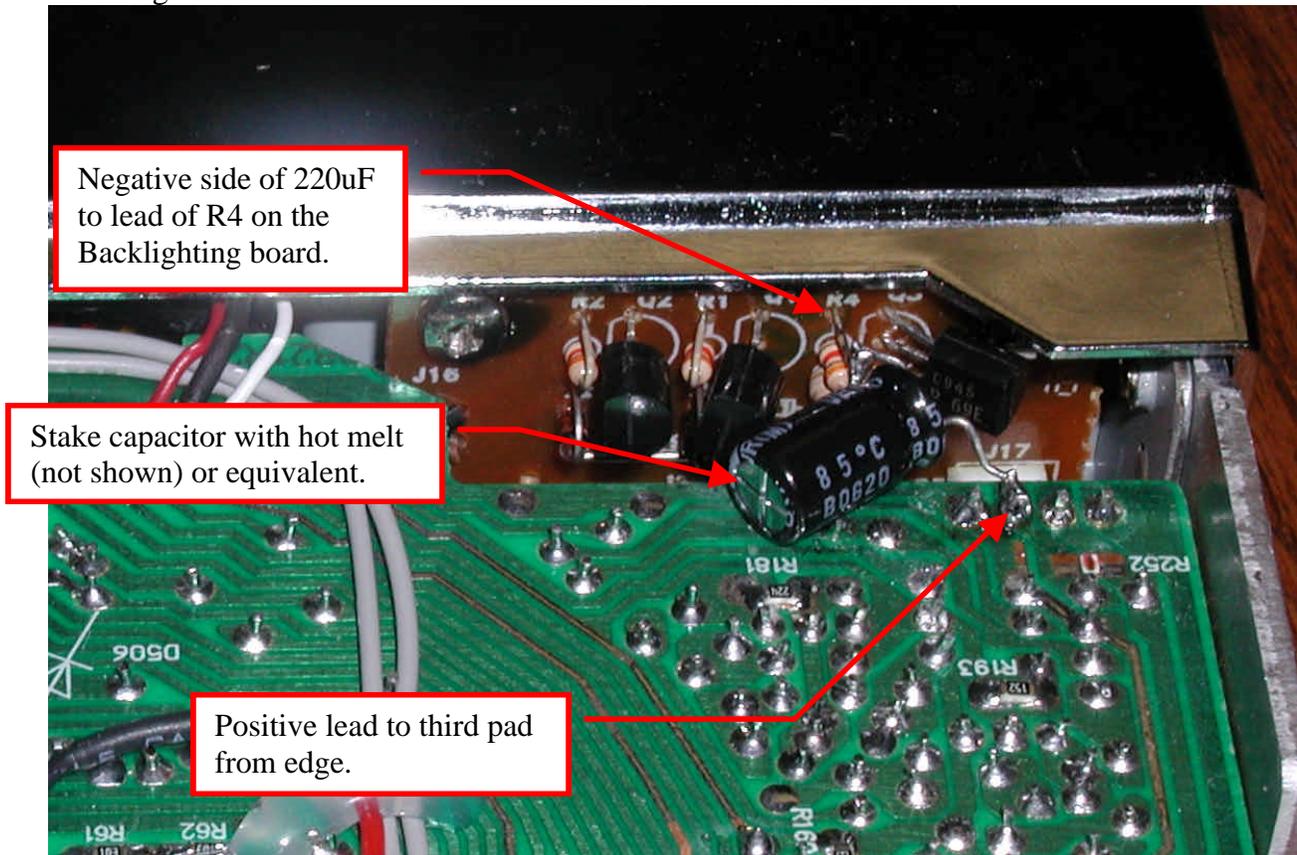
Figure 2: Installing the 220uF Capacitor

This document describes the modification required to reduce noise (motor boating) in a Magnum S6 or S9 radio. This only applies to S6's and S9's that have the new TDA2003 audio power amplifier on the new PCBX-0717.

Add 220uF 16V capacitor positive side to third pin from edge and negative side to lead of R4 on Backlight board. See Figure 2.
